Heavy Rainfall Disaster in Eastern Japan Caused by Typhoon 0206 from July 9 to 12, 2002

ABSTRACT

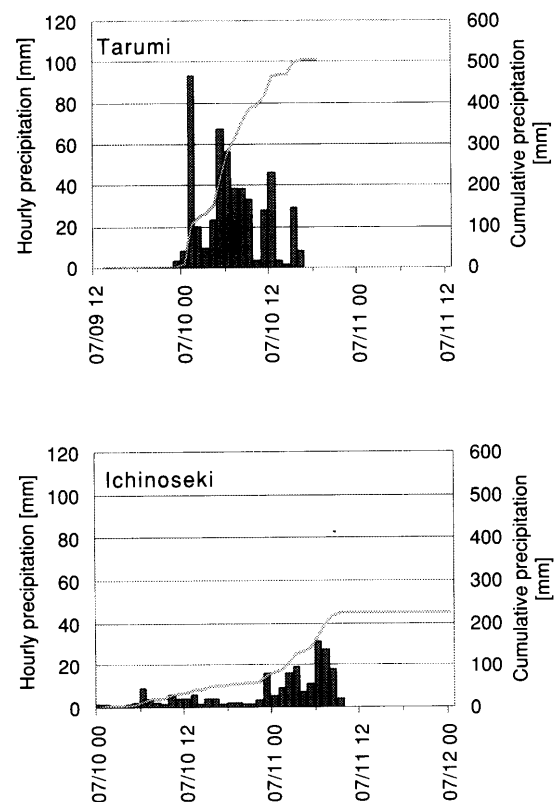
Fig. 4 Hourly and cumulative precipitation at Tarumi (Gifu Prefecture) and Ichinoseki (Iwate Prefecture).

Figure 4 shows hyetographs of Tarumi (Neo Village, Gifu Prefecture) and Ichinoseki (Ichinoseki City, Iwate Prefecture). The highest 48-hour precipitation was recorded at the Tarumi

Rain began at Tarumi before dawn on July 10. The highest 1-hour precipitation (93mm) was recorded at 1 a.m. on July 10. There after, a precipitation of more than 20mm was recorded every hour from between 1 a.m. and noon on July 10. The 48-hour precipitation totaled 506mm. At Ichinoseki, rain began on the morning of July 10. Approximately a rainfall of 10mm per hour was recorded from 11 p.m. on July 10 through 08 a.m. on July 11. The highest 1-hour precipitation (31mm) was recorded at 06 a.m. on July 11. The 48-hour precipitation totaled 223mm.

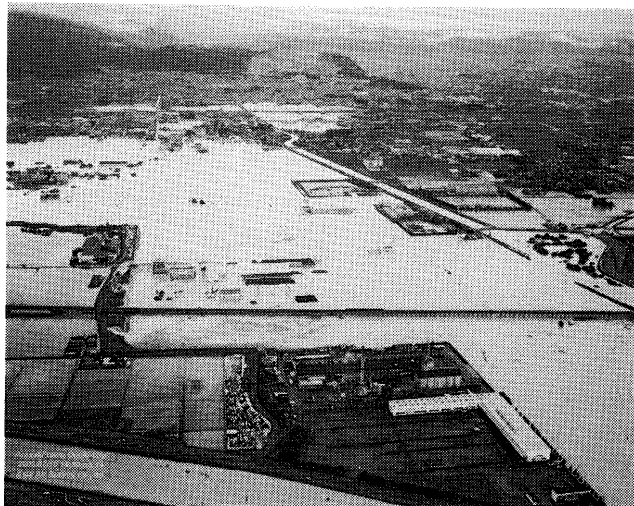
Photo 1 Flood damage in Ogaki City, Gifu Prefecture.
Photograph: July 10, 16:00. The fuse plug levee is on the right. Copyright (C) 2002 Asia Air Survey Co., Ltd.

tion in the residential zone being about 1 m (National Institute for Land and Infrastructure Management, 2002). Most of the damage occurred in the Arasaki area (Photo 1) due to overflow at the fuse plug levee of the Otani River (Photo 2). Residential land development of a lowland paddy zone resulted in this damage. Local residents were not fully aware of the existence and objective of the fuse plug levee. Local people therefore need to be more thoroughly informed about that type structure.

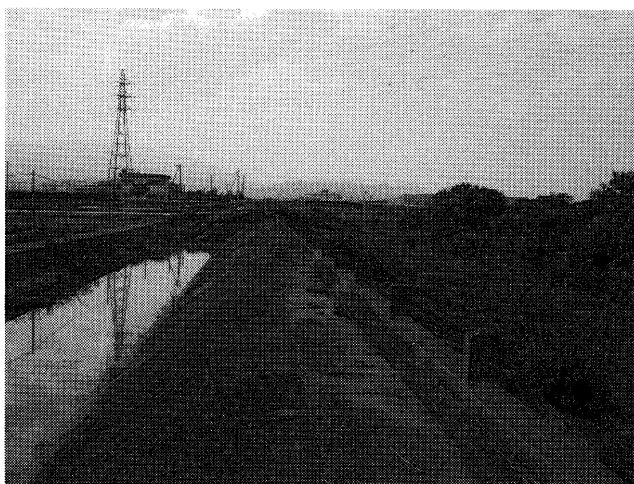
Photo 2 Close-up of the fuse plug levee (Otani River Arai zeki).

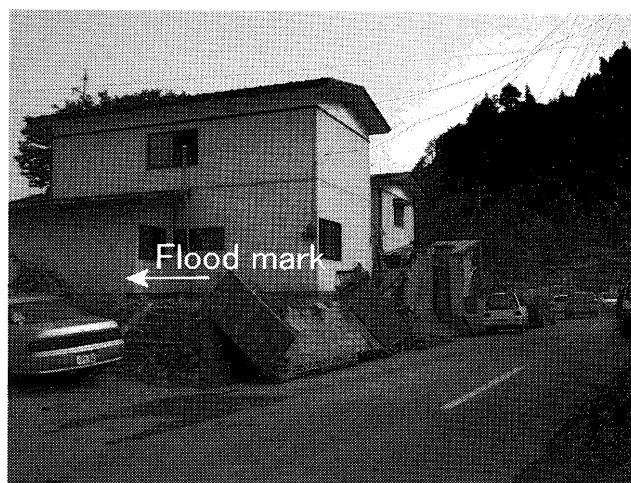
Photo 4 Inundated house in Higashiyama Town.
Inundation by over flow in spite of being built on filled ground (about 1m). The wall was destroyed the river water. Photos 4, 5, and 6 were taken on July 13 by the author.

am on July 11, and overflows occurred everywhere in the central area of Higashiyama Town. Many were inundated, houses and at 6:45 am on July 11, an evacuation order was given. Thirty persons who failed to escape were rescued by helicopter or boat; fortunately there were no deaths. Results of my field survey showed that the inundation depth ranged from 1.5 to 2.0m in the town. Houses with raised basements for flood defense are situated along the Satetsu River, but even these sustained over-floor inundation (Photo 4).

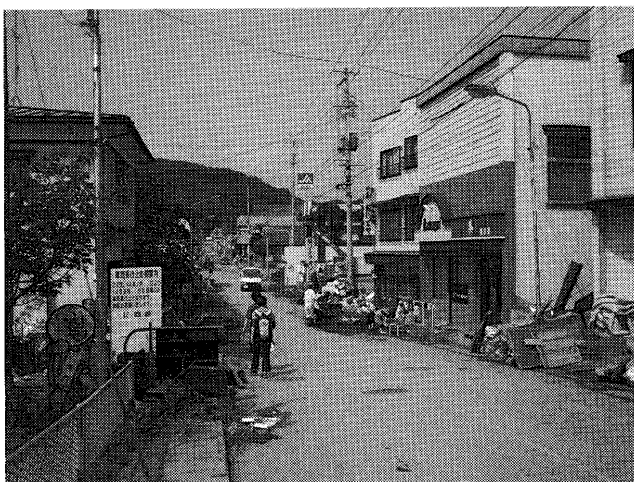
Photo 6 Central Higashiyama Town. Inundation in this area was more than 1m deep. The ground is covered with mud from the river. Piles of refuses from the flooding can be seen along the road.

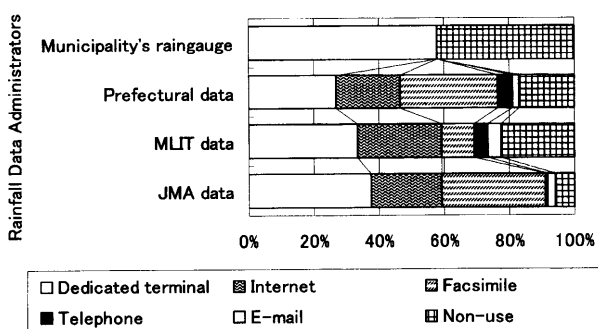
Fig. 7 Methods of real-time rainfall data access by municipal public officials.

The disaster discussed here is one of the first events to have occurred in this Internet age. Therefore, I investigated by questionnaire how to collect and use the heavy rainfall disaster information compiled by local governments. Questionnaire information was gathered from 230 municipalities in Iwate, Miyagi, Fukushima, Gifu and Mie prefectures. Thirty-two of them had issued evacuation orders during the heavy rainfall disaster, half of them answered that the occurrence of damage was the decisive factor in issuing the evacuation order. Results of the questionnaire indicated that in spite of the availability of disaster information it was difficult to issue evacuation order before damage actually occurred. Percentages of rainfall information received in real time based on responses were rainfall JMA data 92%, Ministry of Land, Infrastructure and Transportation (MLIT) rainfall and water level data 72%, prefectural rainfall and water level data 78%. Rainfall information use at the time of the heavy rainfall event were JMA data was 74%, MLIT data 38%, and prefectural data 51%. These findings show that it is not always a real time rainfall information system that is used at the time of an actual disaster. Flood hazard maps were made in 23 municipalities, but only 13 municipalities used hazard maps during this event. It is important that the practi-
