## Characteristics of the Heavy Rainfall Disaster in Central Taiwan, July 29 to 30, 2001.

(Received for 1. Feb., 2002 and in revised form 20 May., 2003)

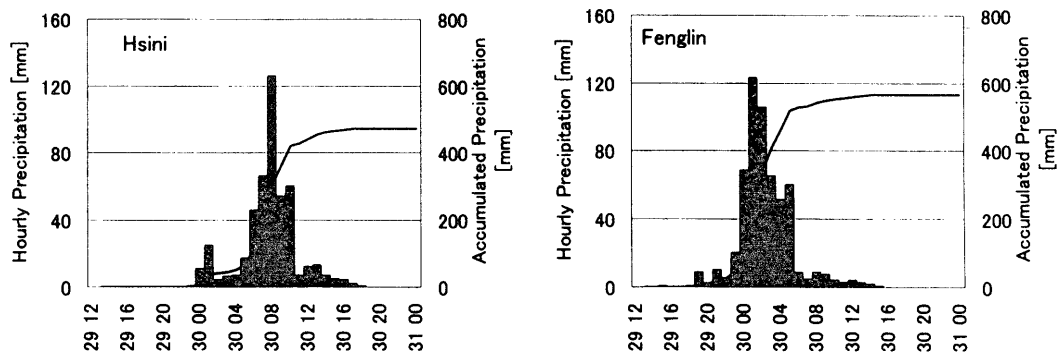
Fig. 3 Hourly and cumulative precipitation at Hsini (Nanto P.) and Fenglin (Hualien P.).

Heavy rainfall (100mm/h or more) lasted for about 3 hours in Hualien and Nanto prefecture in central Taiwan (Fig. 3). The 1-hour precipitation high was 149 mm (Kuangfu), and the 3-hour precipitation high 390 mm (also Kuangfu).

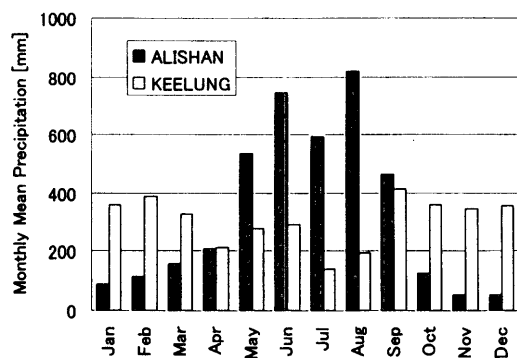
Fig. 5 Monthly mean precipitation at Alishan and Keelung, 1961 to 1990.

Normally, the western plain area of Taiwan receives little annual rainfall, whereas the north and central mountainous areas have high rainfall. (Fig.5, Taiwan Central Weather Bureau, 2001). In the central and southern areas, the rainy season is from May to September, and the difference in precipitation between the rainy and dry seasons is high (Figs. 4, 5).

Nanto Prefecture, which had heavy rain from typhoon No. 0108 is a high rainfall area in Taiwan; e.g., the highest normal monthly precipitation (September) at Alishan is 820 mm. Hualien Prefecture is a lower rainfall area than Nanto Prefecture, the normal highest monthly precipitation at Hualien City is 385 mm and

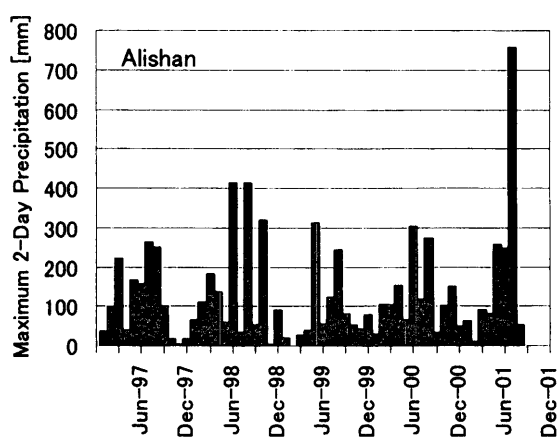
Fig. 6 Monthly highest 2-day precipitation at Alishan, Jan. 1997 through Aug. 2001.

The highest 2-day precipitation at Alishan per month from 1997 to 2001 is shown in Fig. 6. Each year there have been a few 300mm or more 2-day precipitations recorded, but no event comparable to the heavy rainfall of July 29-30 had occurred in the pre-

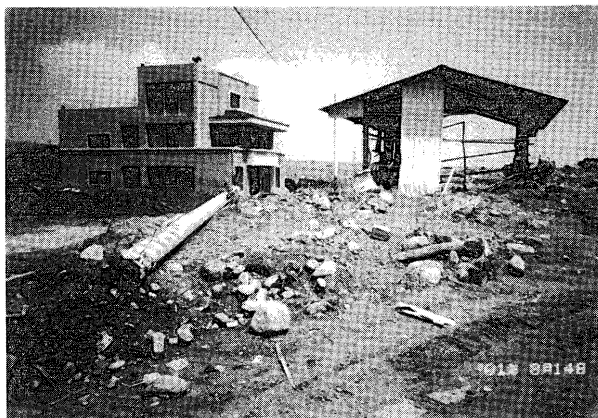
Photo 1: Flood damage at Mujiliao Village

Village in the low elevation area. There after, the left river bank was breached downstream of the bridge, and the flood flow battered the village (Fig.8). That is, flood flows caused by both the overflow and bank breach struck the village at separate time. According to members of the Disaster Prevention Research Center of National Cheng Kung University who accompanied us, the maximum discharge at that time amounted to more than 1,630m<sup>3</sup>/s the 50 year return period discharge.

In the upstream area of the Tungpurei River, rainfall intensity increased from dawn 30 July, and the highest river water stage occurred at about 8:30 on 30 July near the bank breach location. According to residents of the village, at about 7:30, those who had been informed of the high river water stage started to evacuate the village. As houses were destroyed by the flood flow just after 8:30, the lives of some of the residents may have been saved by that evacuation. Many large boulders with a maximum diameter of more than 1m were deposited along the trace of the flood flow. The flood flow carried a great deal of sediment. Moreover, the pass that the water flowed down was very narrow, indication that the flow occurred at high speed without stoppage or diffusion. In the stricken village, there was very little distance between completely destroyed houses and those that remained intact.

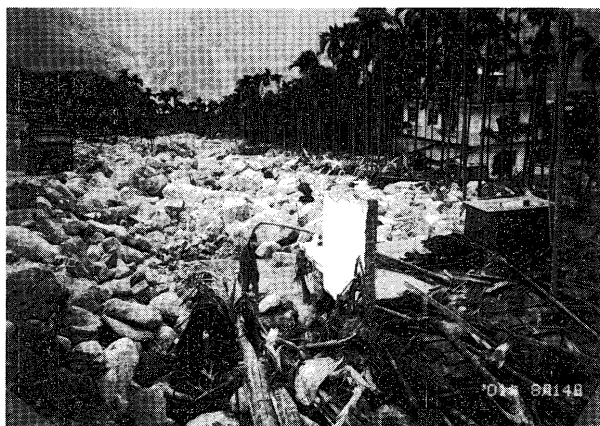
Photo 2 Result of the sediment disaster at Chunkeng Village

Along the national road from Shuili to Hsini, some villages located on steep slope areas had been destroyed by debris flows. Heavy damage caused by debris and sediment flows in particular occurred at Chunkeng in Shuili County, at Hsinhsiang in Hsini County and elsewhere. Photo 2 shows Chunkeng Village after the debris flow. This photo clearly indicates the severity of the debris flow by the trace it left. In this village, the first floor of the social activities center was demolished by huge boulders. The building which, if in Japan, would be used as a refuge shelter was badly damaged by the debris flow. Further upstream, the scale of the debris and sediment flows damage was even greater, and huge boulders and large deposits of sediment could be seen in many places in Hsini County. Moreover, many roads and bridges also were damaged.

Although the cause of those sediment disasters clearly was the heavy rainfall of more than 400mm that occurred during 24 hours,

previously this area had frequently experienced heavy rainfall; heavy rainfall greater than that of 2001 event had been recorded five years before, but no severe sediment damage was reported at that time. Due to the heavy rainfall, the great volume of unstable sediment left by the Chichi earthquake of September 1999 in the mountainous area, may have moved and flowed down abruptly.

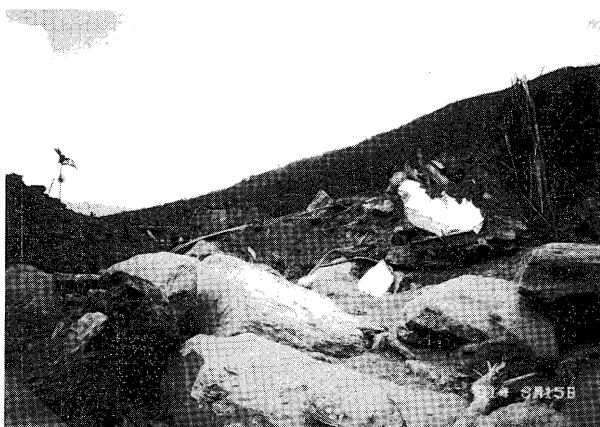
Photo 3 Debris left by the sediment disaster at Tashing Village

At Tashing Village, the large scaled debris flow was caused by slope failure. An enormous volume of gravel and sediment yield flowed down, some of which overflowed the bank and struck houses and fields. Photo 3 shows part of destruction at Tashing Village. Forty-one persons died or were missing. About 200 houses were damaged, 16 of which were completely destroyed, and about 50 hectares of fields were buried under sediment. Maximum sediment accumulation thickness was 15m, and the total volume of sediment moved was estimated to be about 1.5 million m<sup>3</sup>. Public officials of the Hualien prefectural government said that when removal of the sediment and driftwood was finished, they planned to make residents affected by the debris flow move to a new location.
